Wasden Property Inspection, LLC  
P.O. Box 1058  
Fort Benton, Montana 59442

# Home Inspection Report

1234 Main Street  
Great Falls, Montana 59405

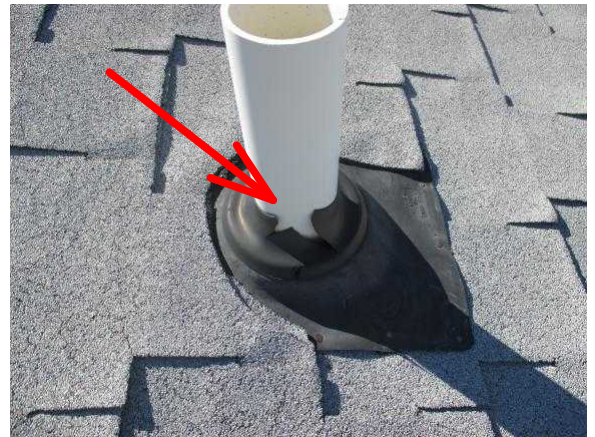
Penetrations: *Defective - Plumbing vent flashing was defective and may allow rain and snow melt into the attic. A qualified roofing contractor is recommended to evaluate and estimate repairs.*

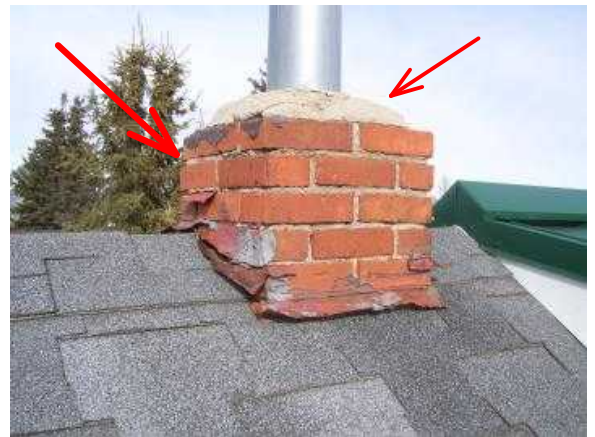
Chimney: *Marginal - Chimney had loose mortar joints, requires tuck point repairs. Chimney crown is cracking and needs repair to prevent water intrusion.*

*A qualified contractor is recommended to evaluate and estimate repairs.*

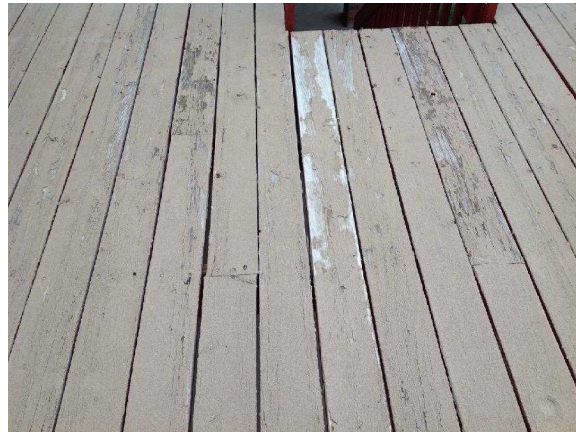
Deck/Balcony: *Marginal* - Deck components exhibited moderate weathering and deterioration at the time of the inspection.

The deck should have routine maintenance performed on a regular schedule.

Consider consulting with a qualified contractor to discuss options and costs.

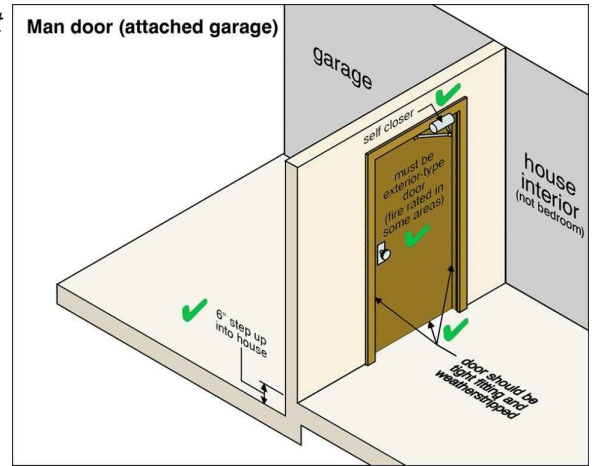
Windows/Doors: *Acceptable* - The door connecting the home was not fire rated. Fire ratings may not have been required when this home was built. Consider upgrading in the future for safety.

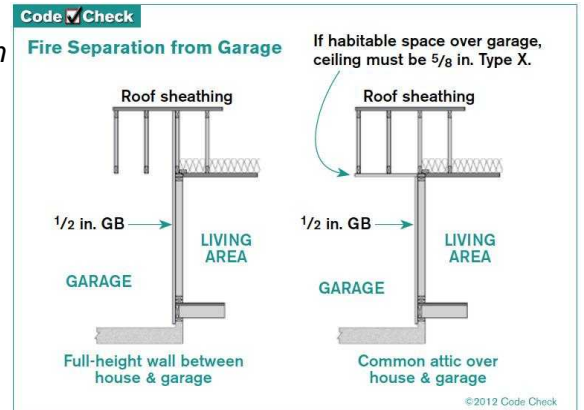
Ceiling/Walls/Floor: *Acceptable* - The wall between the garage and home was not fire rated. Fire ratings may not have been required when this home was built. Consider upgrading in the future for safety.

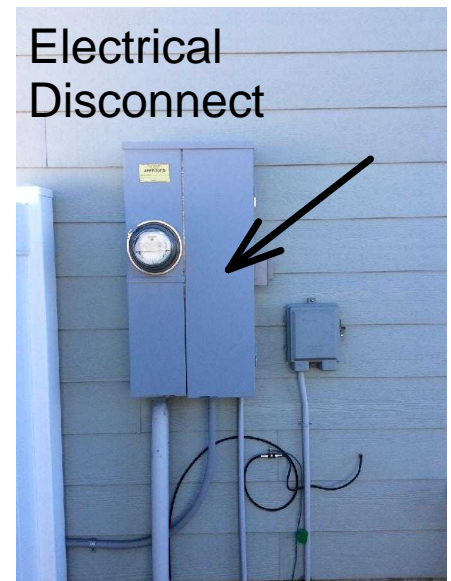
Main Disconnect Location: *Exterior, Side*

Main Service Amperage: *200 Amps*  
Type of Wiring: *Romex*  
Service: *Acceptable*  
Main Panel: *Acceptable*

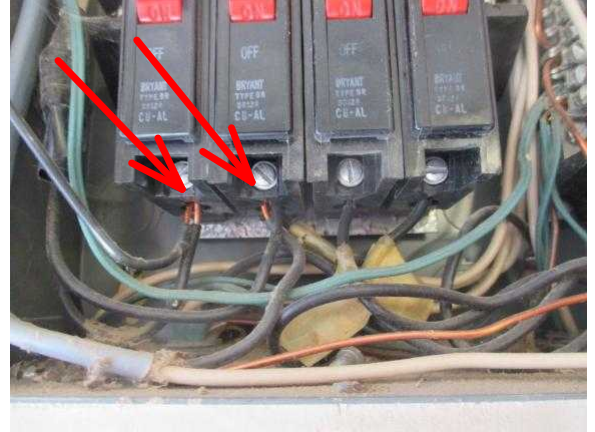
Sub Panel: *Marginal - Double taps of branch circuits, Not a recommended practice, A licensed electrical contractor is recommended to evaluate and repair*

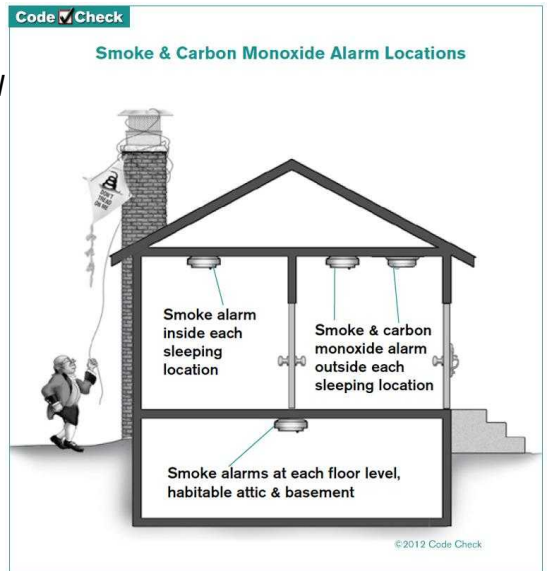
Smoke & C/O Detectors: *Not Present - Although smoke detectors may not have been required in every bedroom when this home was built, they provide life saving warnings in case of fire. They are inexpensive to install and are recommended for life safety.*

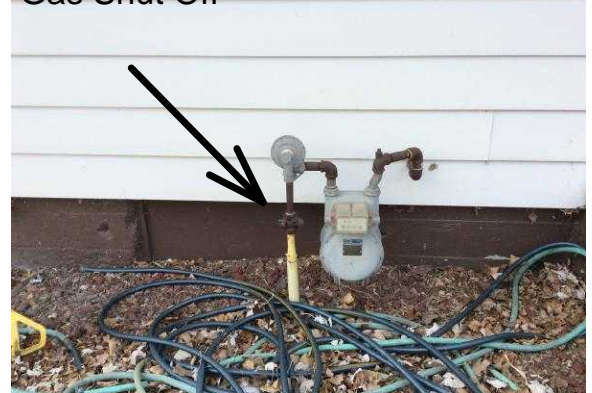
Gas Shut Off Location: *Rear of House, At Meter*

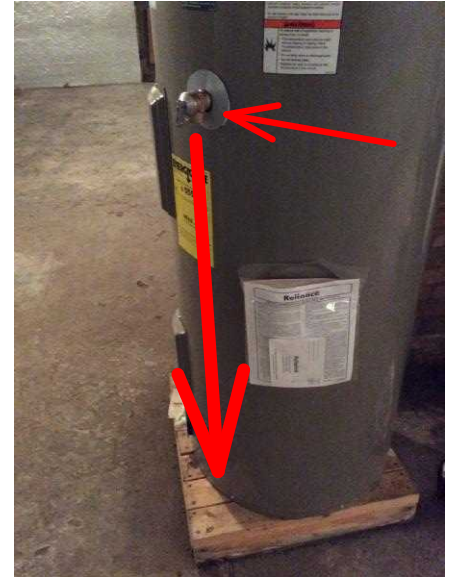
Water Heater Components: *Defective - Drain tube discharge opening for the temperature & pressure relief valve was not within six inches of the floor. This condition is a scald hazard and should be corrected by a licensed plumber.*

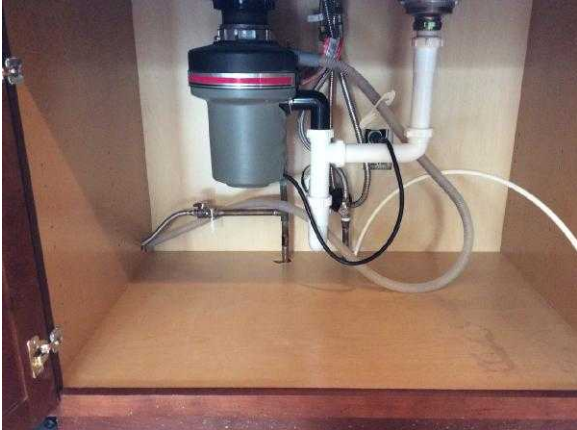
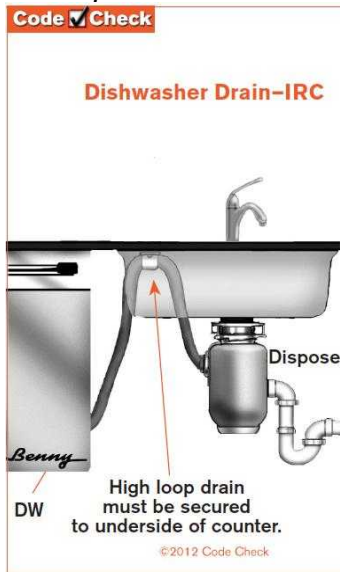
Appliances: *Acceptable* - Dishwasher drain not looped high and may allow sewage backup into unit. Consider routing the drain hose up high under the counter to prevent this or install an air-gap.

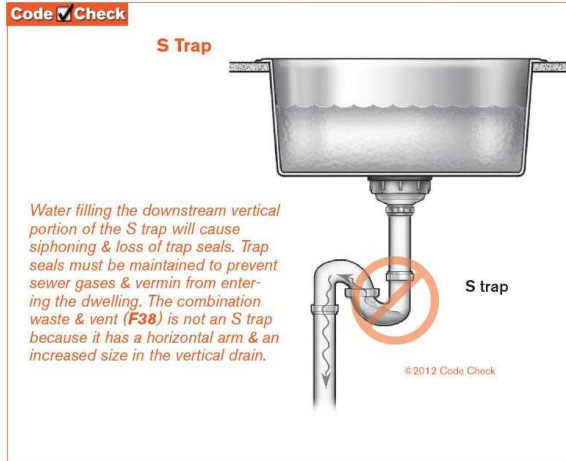
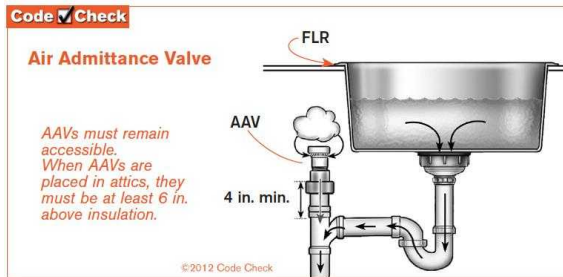
Plumbing/Fixtures: *Marginal - S-Trap may allow sewer gas into home. An air admittance valve is recommended if odor is noticed.*

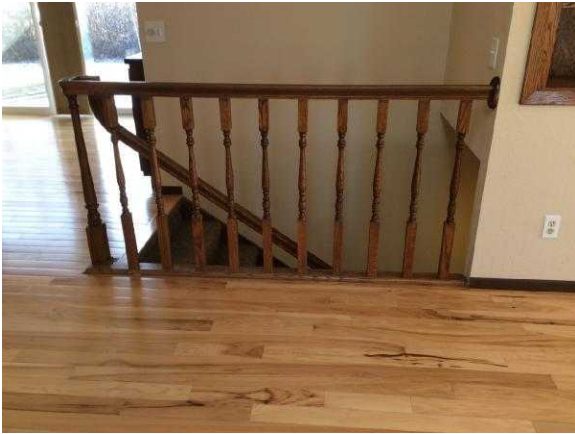
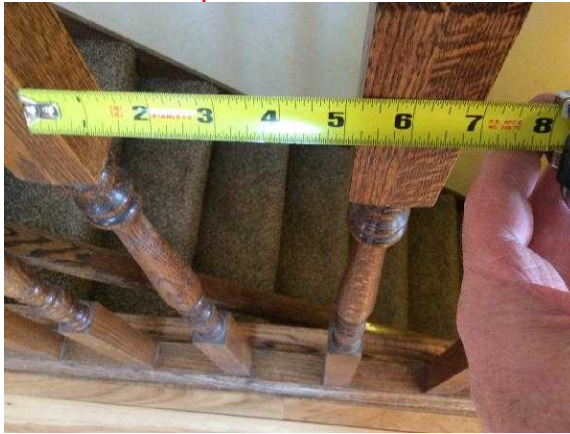
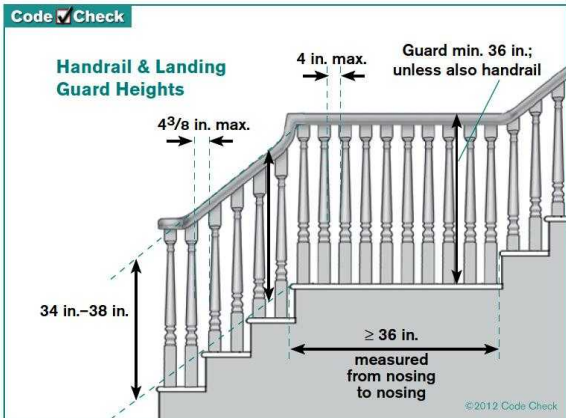
Stairs: *Safety Hazard - Handrails were missing.*

*Current building safety standards require baluster spacing no more than 4" to 4-3/8" wide to prevent injuries to small children.*

*A licensed contractor is recommended for evaluation and repair.*

2. Living Room Living Space Stairs: *Safety Hazard - Handrails were missing. Current building safety standards require baluster spacing no more than 4" to 4-3/8" wide to prevent injuries to small children. A licensed contractor is recommended for evaluation and repair.*

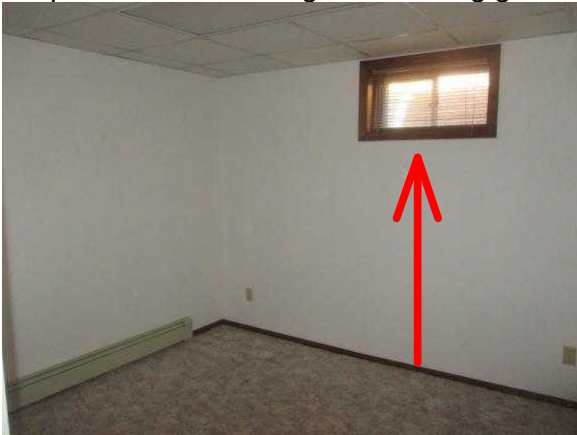
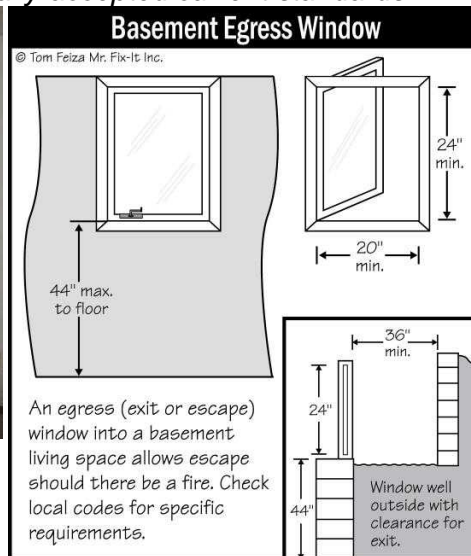
Windows/Doors: *Acceptable - At the time of the inspection this sleeping room in the home had no openings in the exterior walls which would meet generally-accepted current standards for emergency escape and rescue openings. Current standards require a properly-configured wall opening be installed in all sleeping rooms.*

*At the time this home was built, generally-accepted standards may have been different from current generally-accepted standards. For safety reasons, consider installation of an opening in this sleeping room which will provide means of egress meeting generally-accepted current standards.*

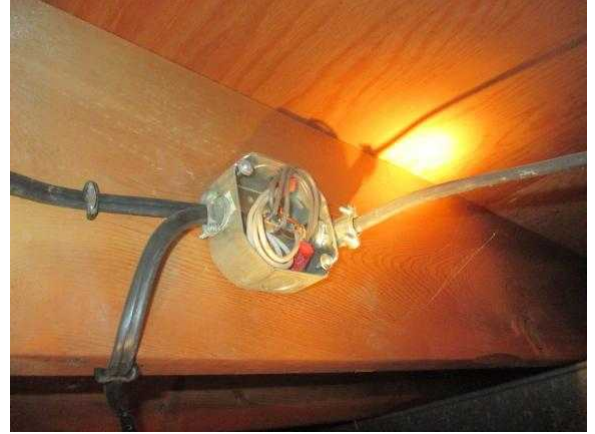
Electrical: *Safety Hazard - Open junction boxes. A licensed electrical contractor is recommended for evaluation and repair.*

4. Main Attic Electrical: *Safety Hazard - Open junction boxes. A licensed electrical contractor is recommended for evaluation and repair.*

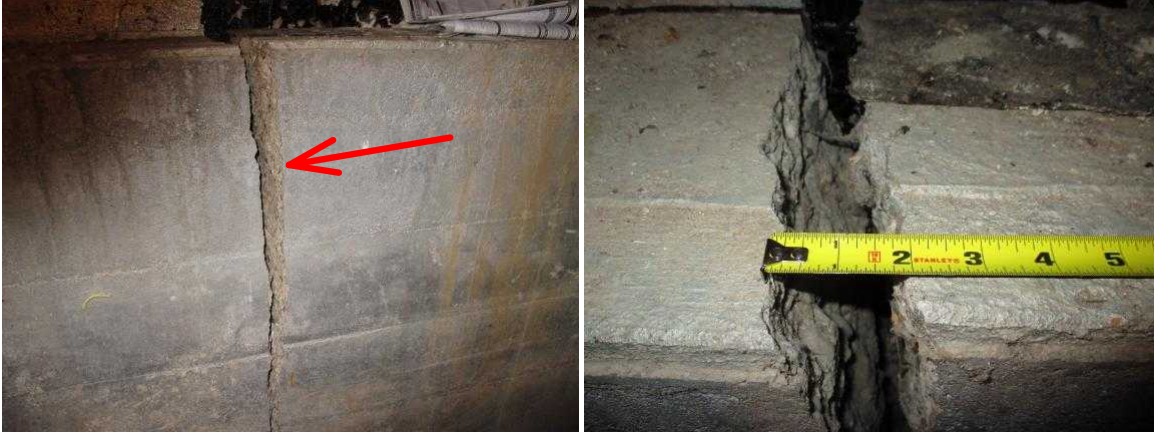
Foundation: *Major Concern - Vertical crack/s, Evaluation by a licensed structural engineer or foundation contractor is recommended.*

1. Foundation: *Major Concern - Vertical crack/s, Evaluation by a licensed structural engineer or foundation contractor is recommended.*
